## I-80/Hiddenbrooke Parkway Interchange Project Preliminary Delineation of Wetlands and Other Waters Solano County, California

Project #3328-21

December 1, 2020

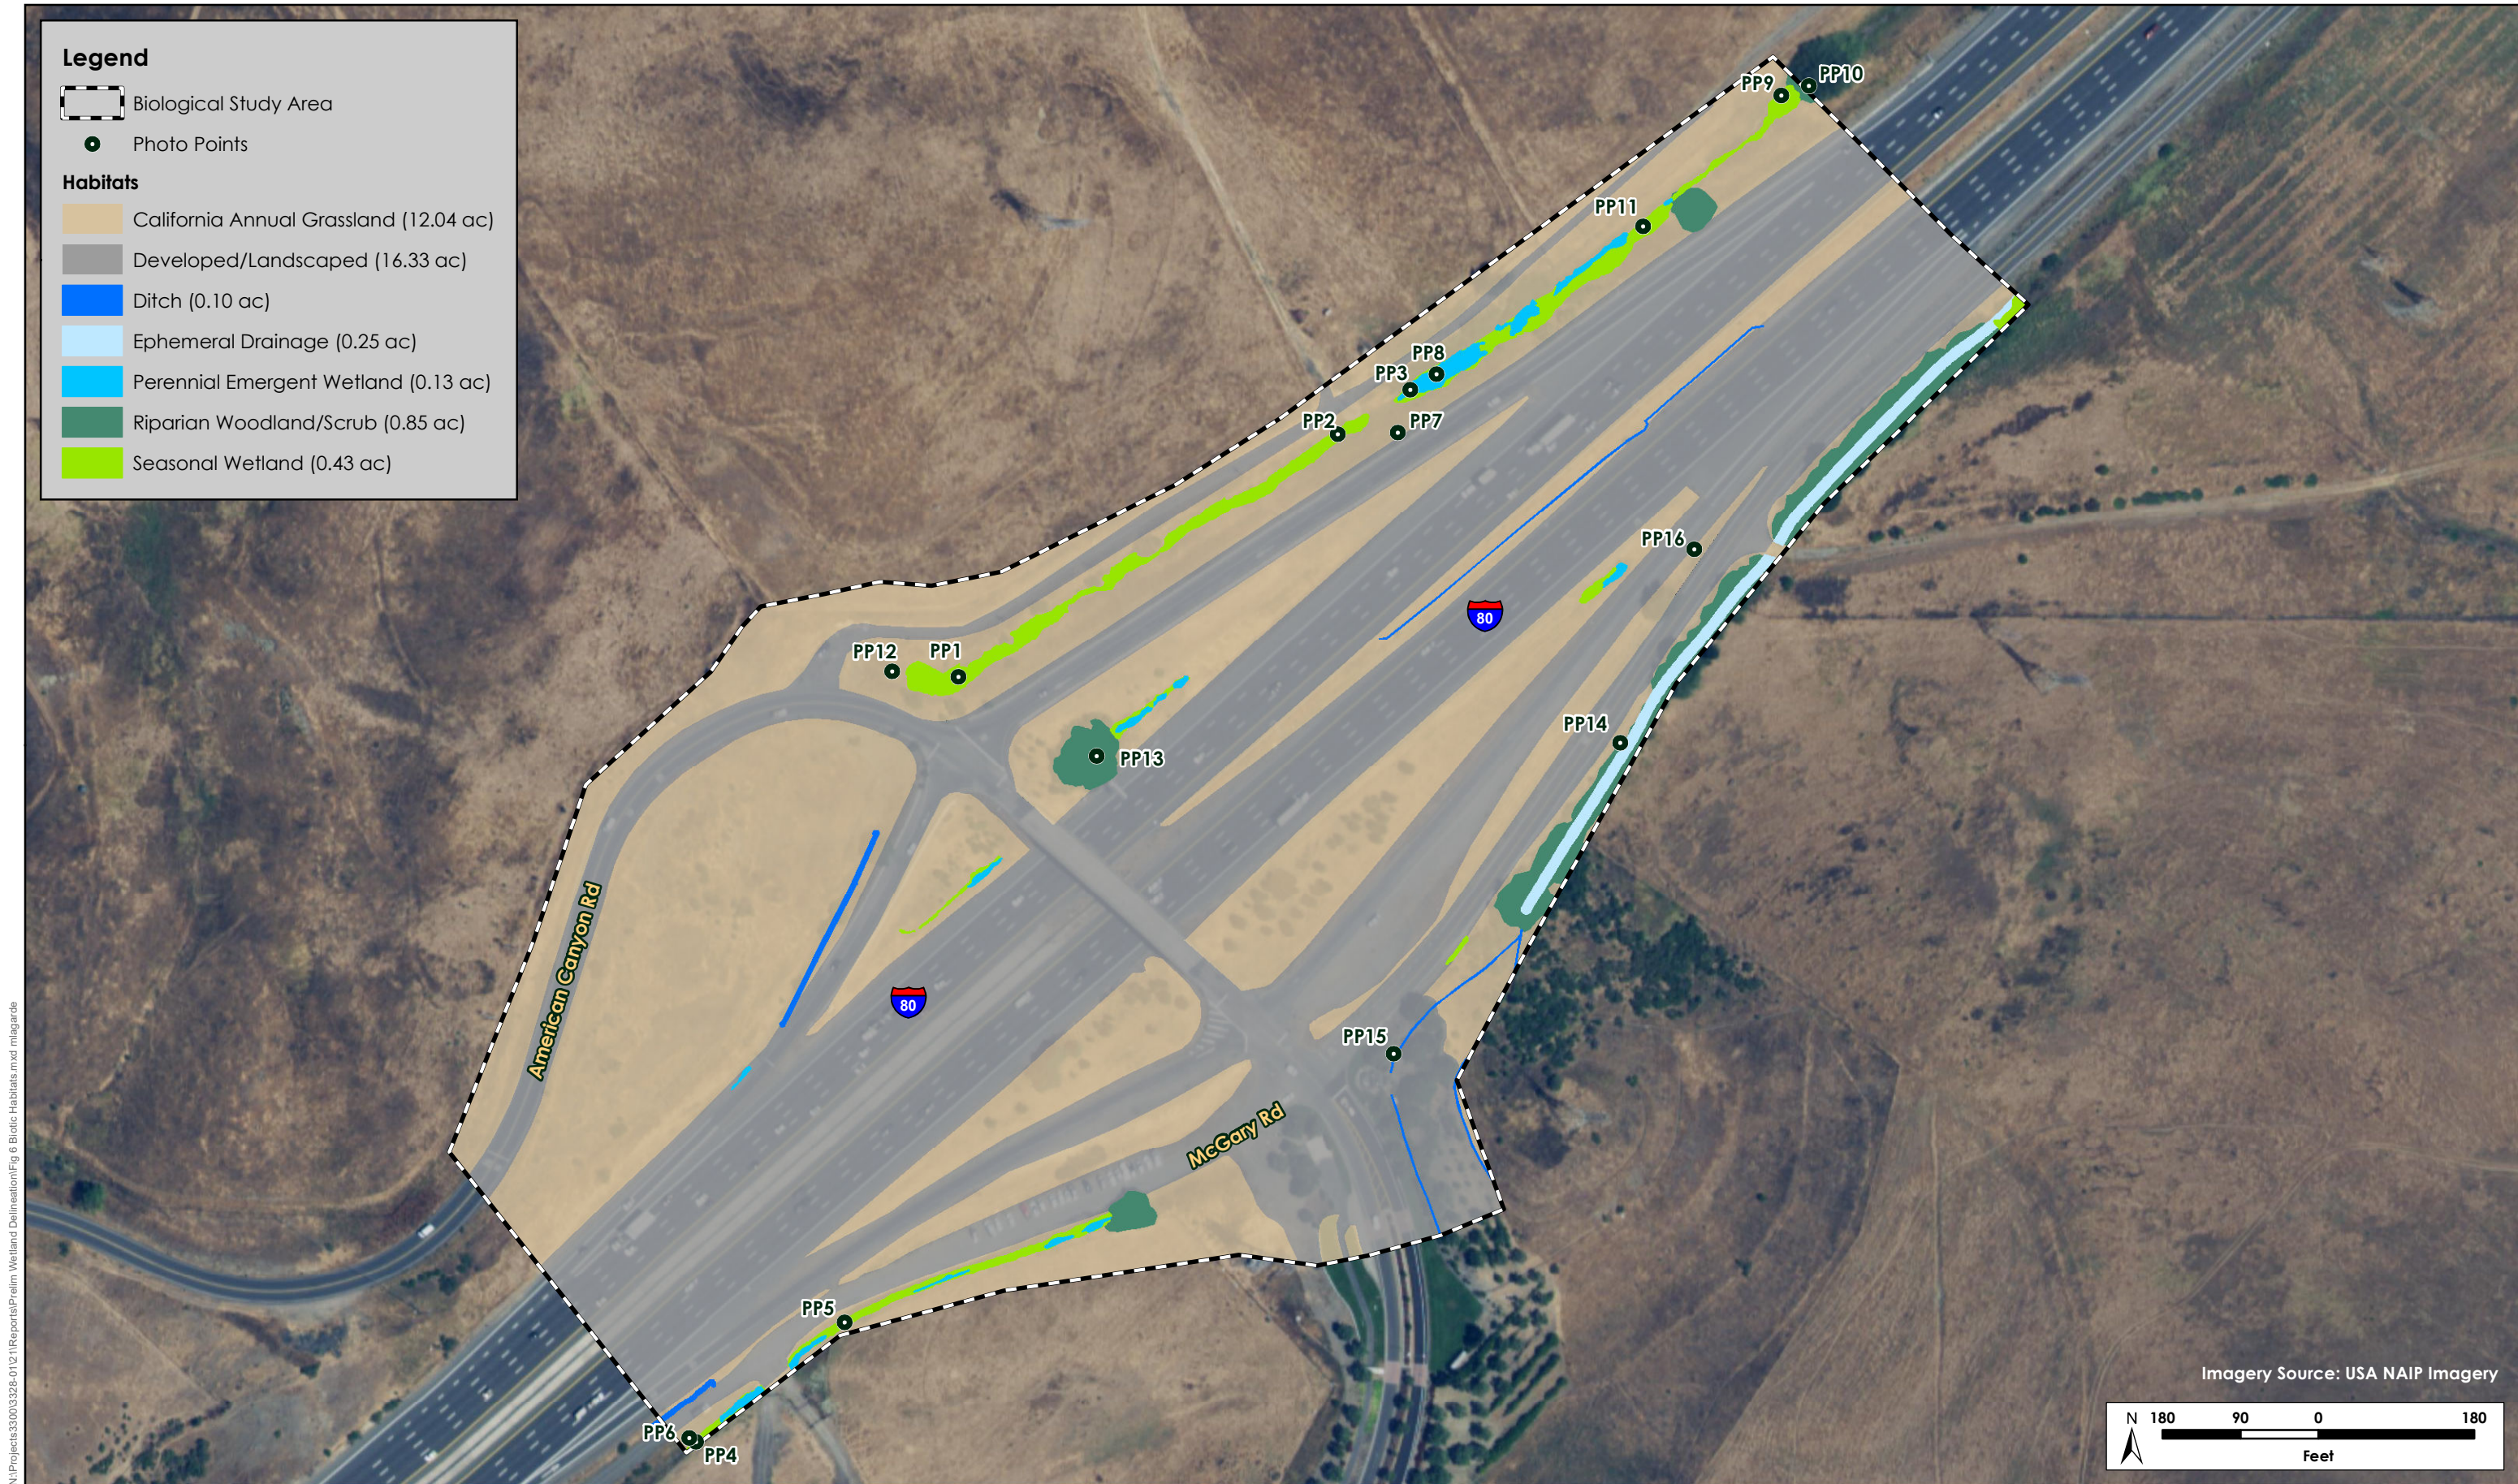
N:\Projects\3300\3328-0121\Reports\Prelim Wetland Delineation\Fig 6 Biotic Habitats.mxd mlagarde

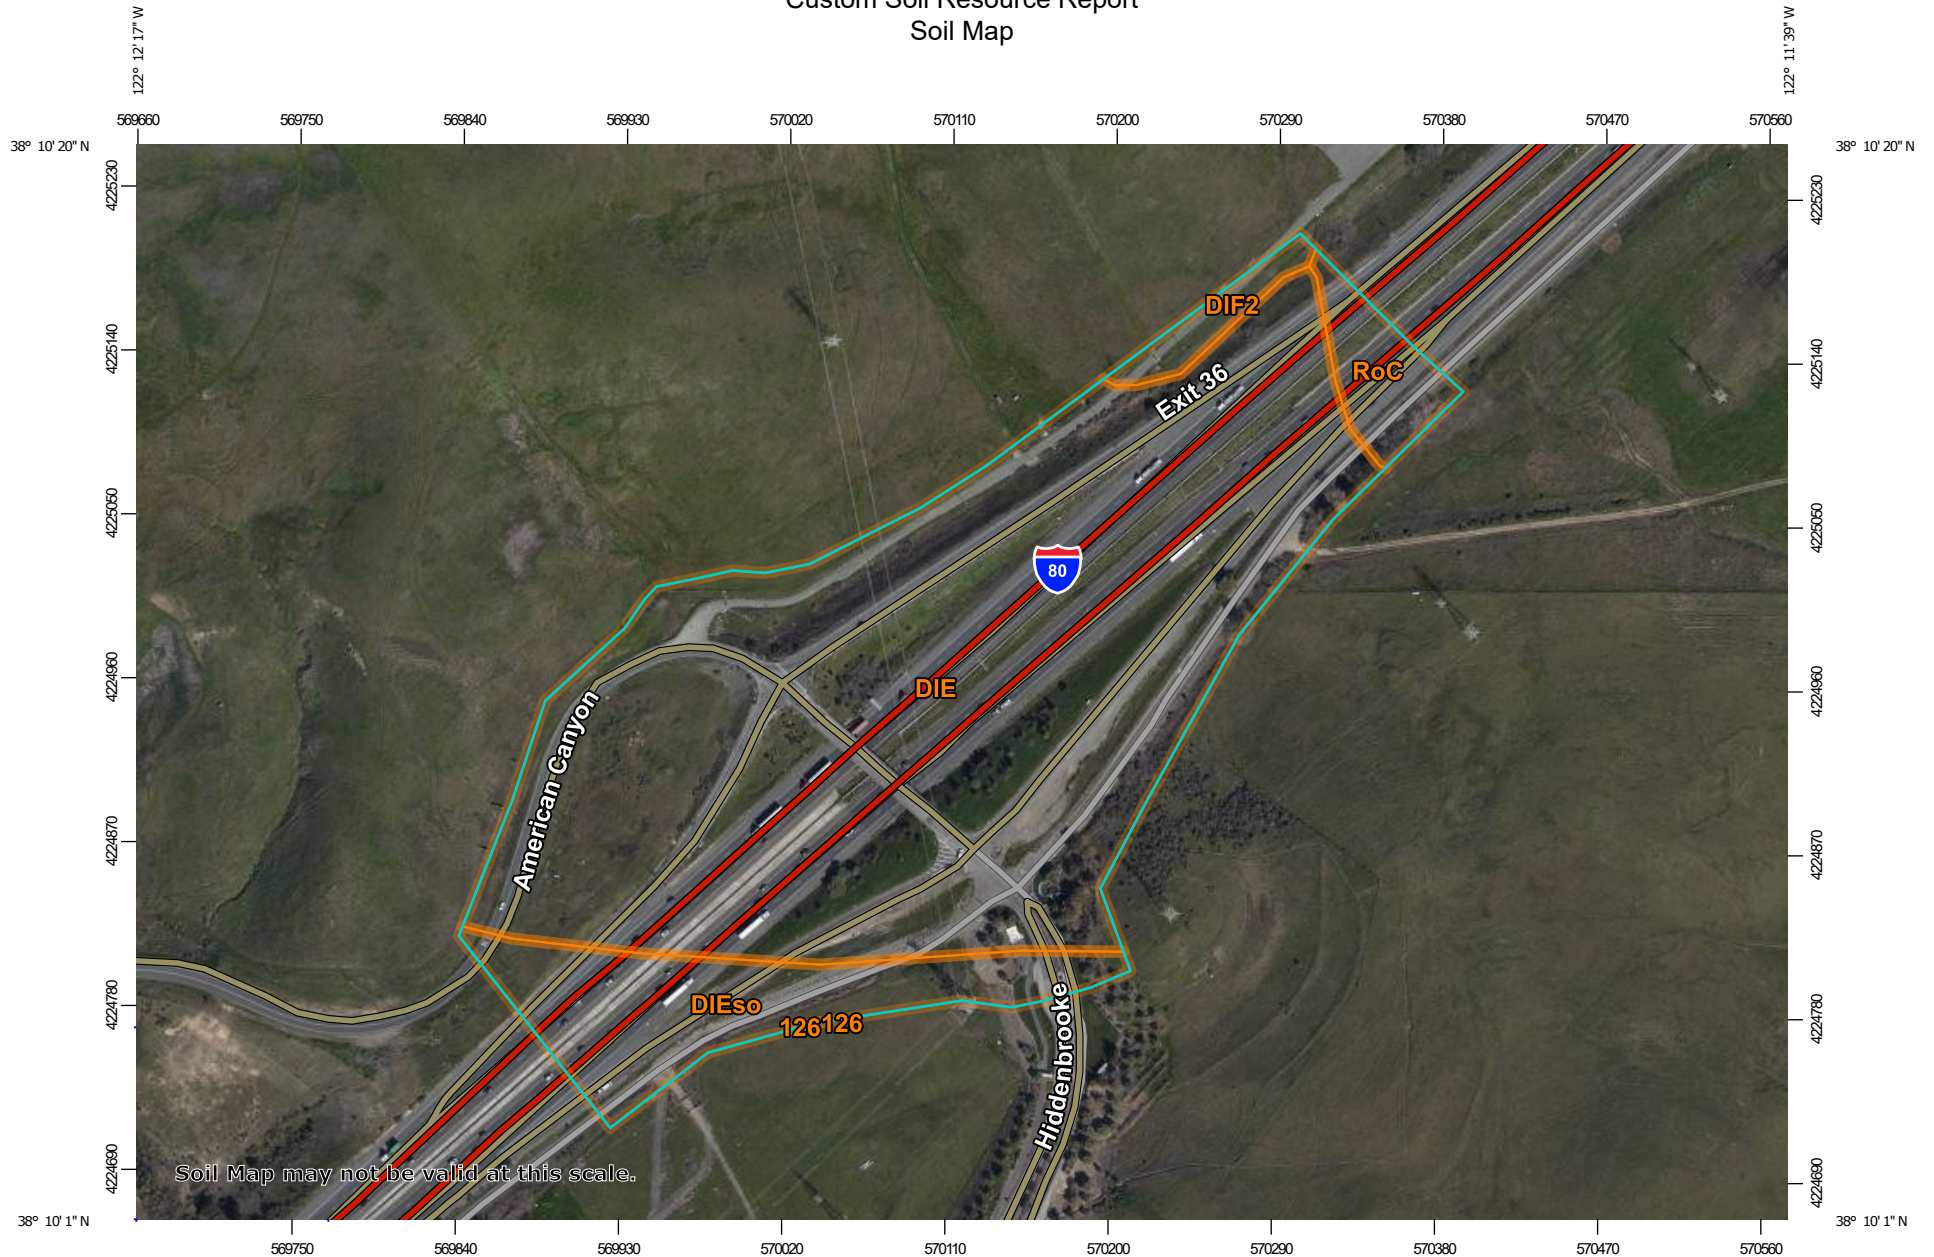
# Custom Soil Resource Report Soil Map

The soil map section includes the soil map for the defined area of interest, a list of soil map units on the map and extent of each map unit, and cartographic symbols displayed on the map. Also presented are various metadata about data used to produce the map, and a description of each soil map unit.

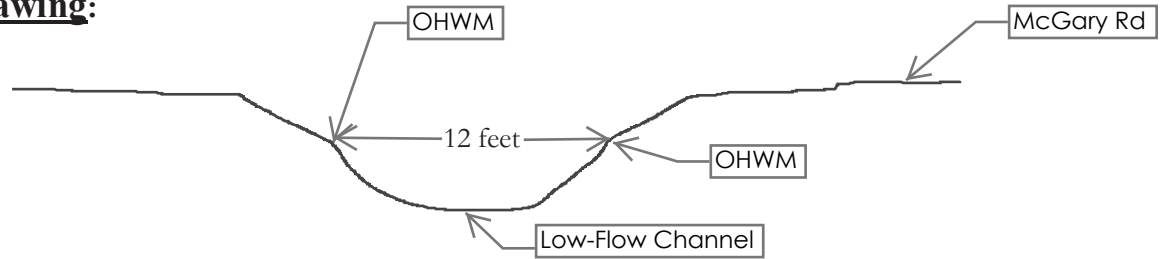
**Cross section drawing:**

**OHWM**

GPS point: 38.170920°, -122.196970° and 38.170896°, -122.196936°

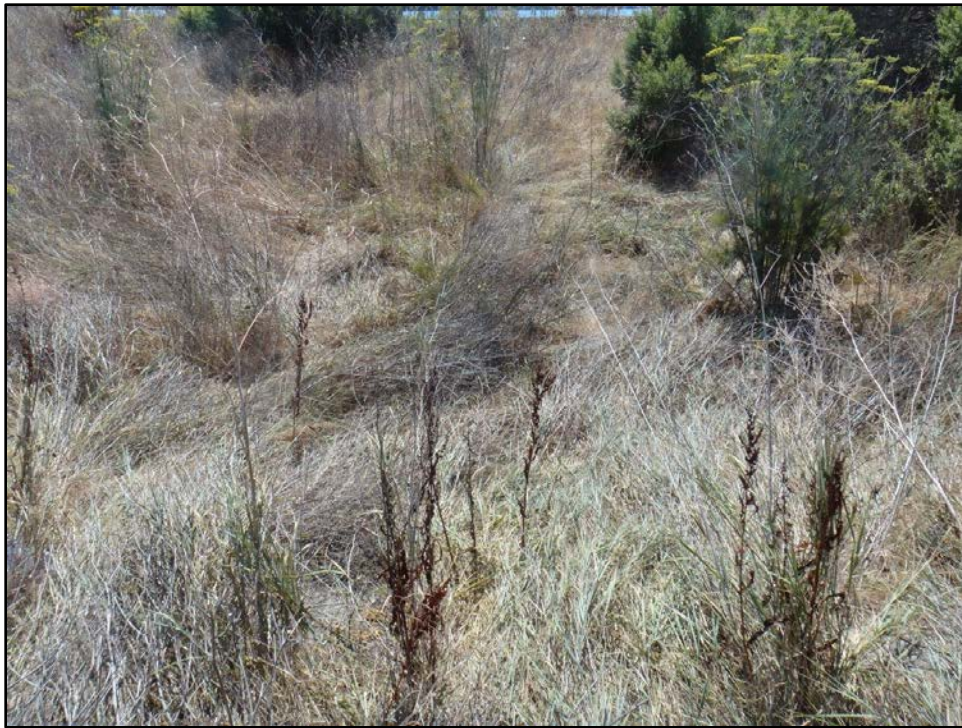
**Photo 1. Sample point SP1 taken to investigate a low-lying area between the westbound I-80 offramp and a frontage road. SP1 was determined to be a three parameter seasonal wetland (SW5). Photo direction = southeast.**

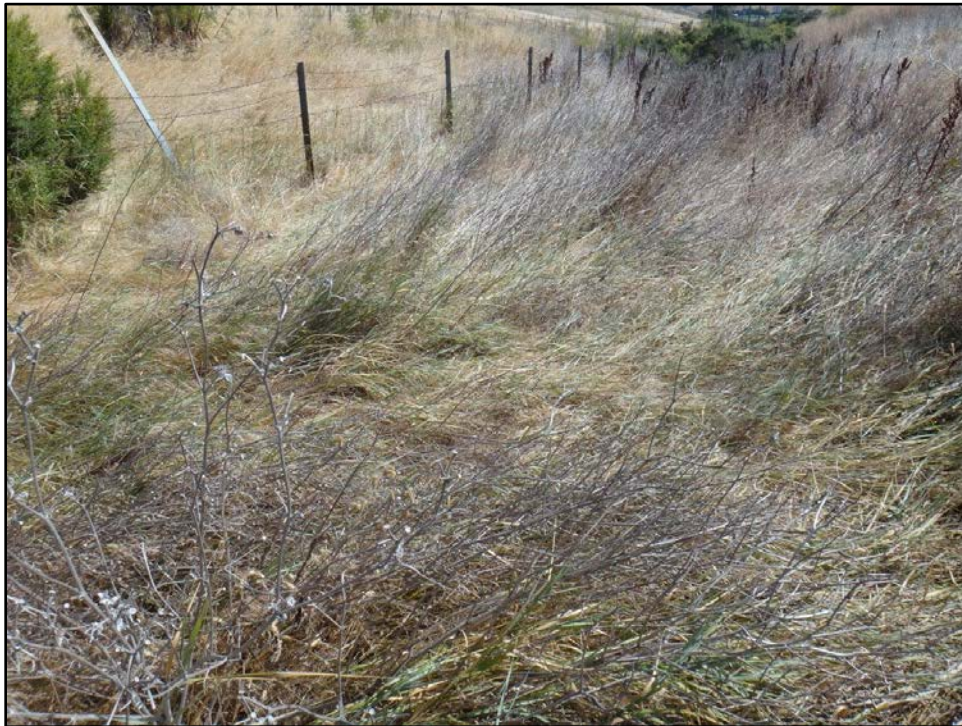
**Photo 2. Sample point SP2 taken to investigate a low-lying area between the westbound I-80 offramp and a frontage road. SP2 was determined to be a three parameter seasonal wetland (SW5). Photo direction = northeast.**

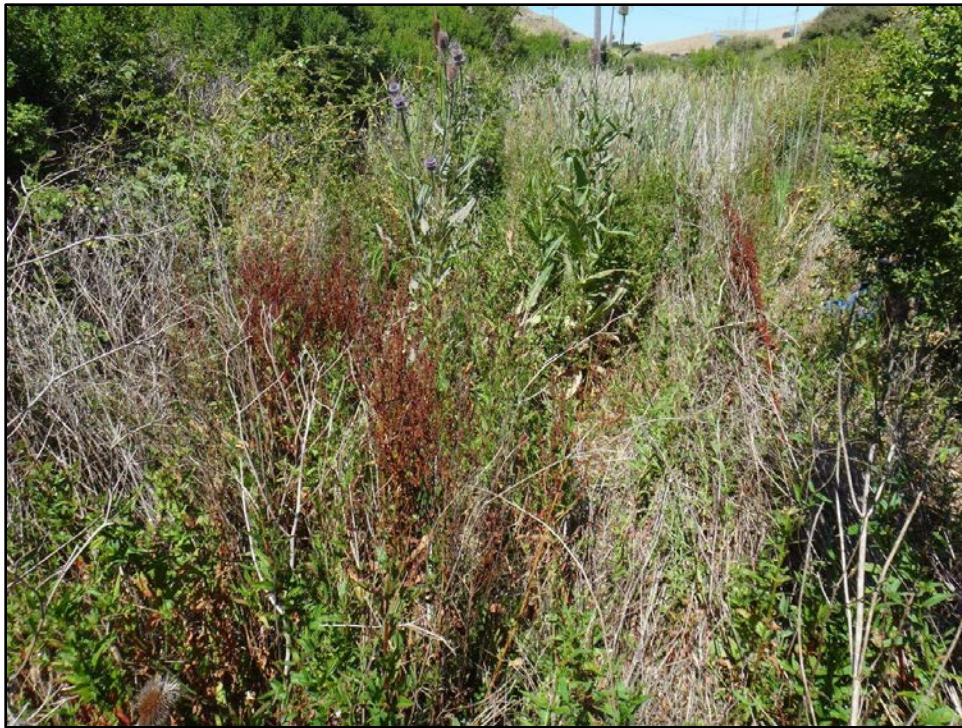
**Photo 3.** Sample point SP3 taken to investigate a low-lying area between the westbound I-80 offramp and a frontage road. SP3 was determined to be a three parameter perennial emergent wetland (PEW12). Photo direction = northeast.

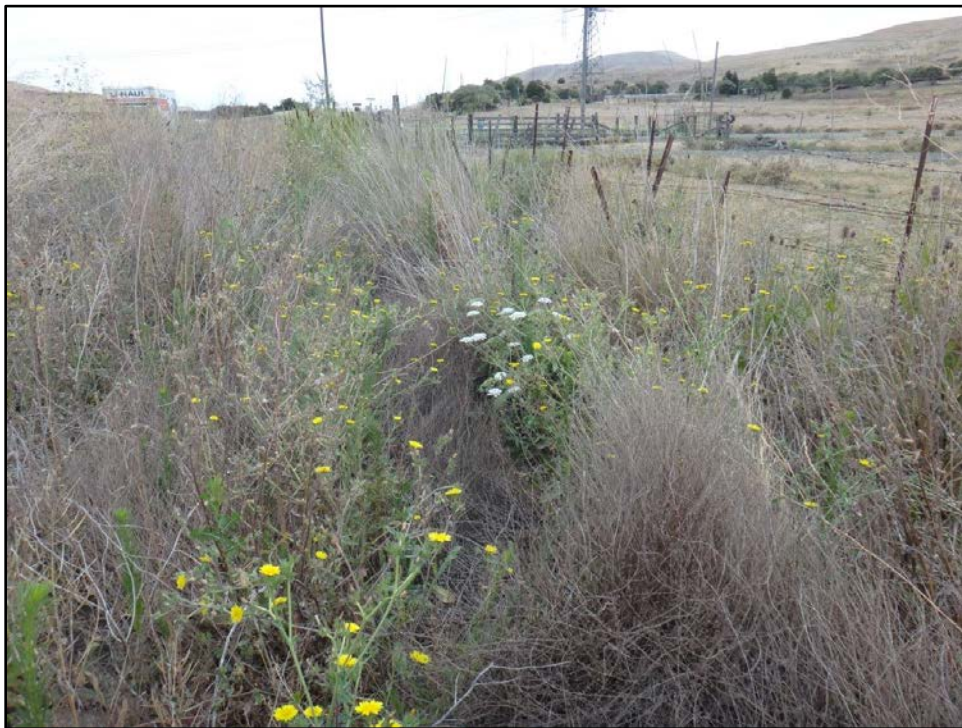
**Photo 4.** Sample point SP4 taken to investigate a low-lying area along the south side of McGary Road south of Hiddenbrooke Parkway. SP4 was determined to be a three parameter seasonal wetland (SW1). Photo direction = northeast.

- SP4 was placed to investigate a concave surface in a low-lying area along the south side of McGary Road south of Hiddenbrooke Parkway. The low-lying area receives seasonal runoff and landscape irrigation runoff from hillslopes, paved roads, and culverts. SP4 is dominated by a facultative species, bristly ox-tongue (*Helminthotheca echioides*). Surface soil cracks are present, which is an indicator of wetland hydrology (B6).

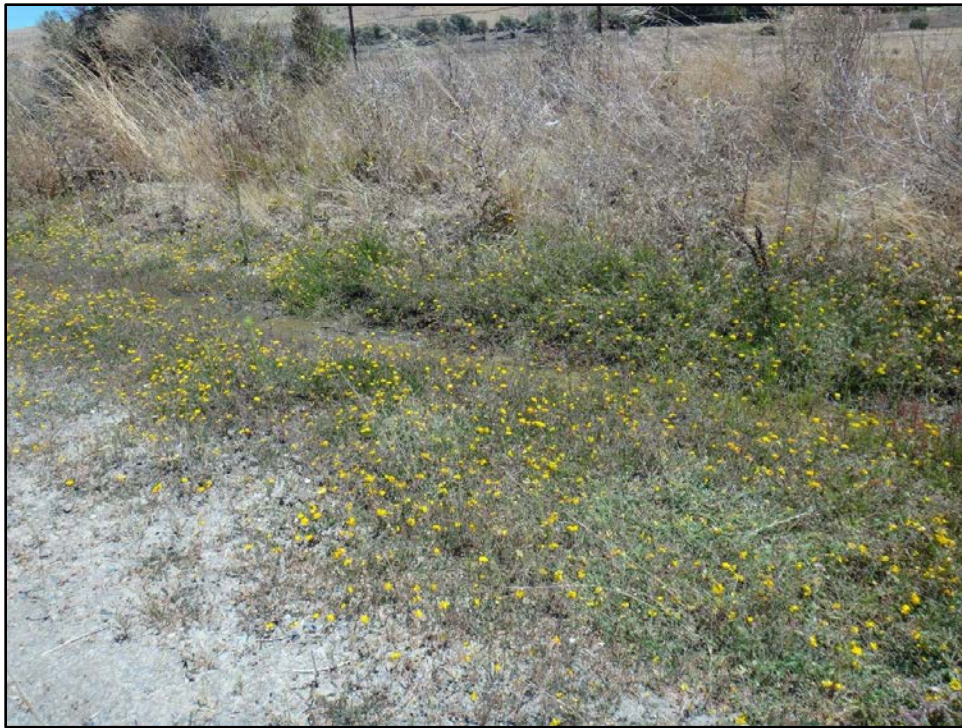
**Photo 5. Sample point SP5 taken to investigate a low-lying area along the south side of McGary Road south of Hiddenbrooke Parkway. SP5 was determined to be a three parameter seasonal wetland (SW2). Photo direction = east.**

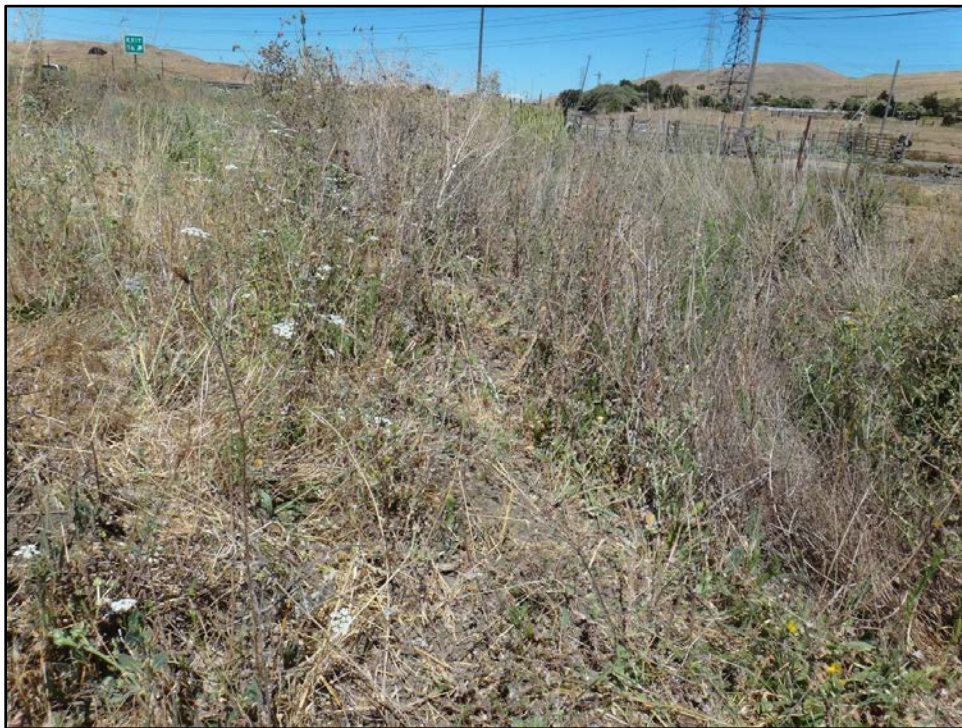
**Photo 6. Sample point SP6 taken to investigate hillslope next to a ditch along the south side of McGary Road south of Hiddenbrooke Parkway. This location was determined to not be a three parameter wetland. Photo direction = southeast.**

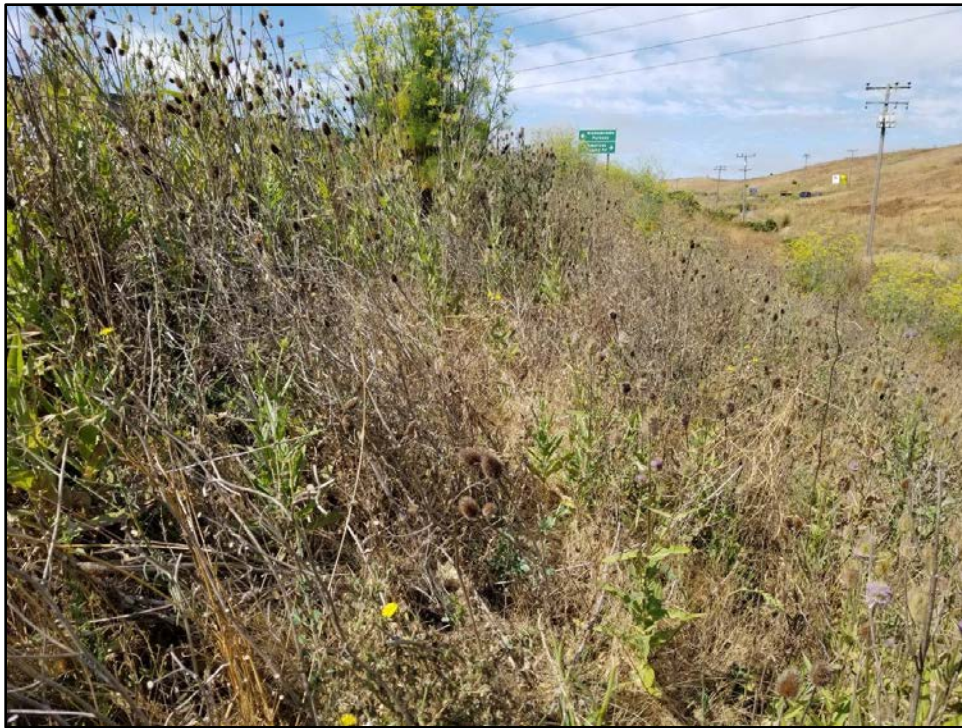
**Photo 7. Sample point SP7 taken to investigate hillslope between the westbound 1-80 offramp and frontage road. This location was determined to not be a three parameter wetland because it lacks indicators of hydric soil and wetland hydrology. Photo direction = southwest.**

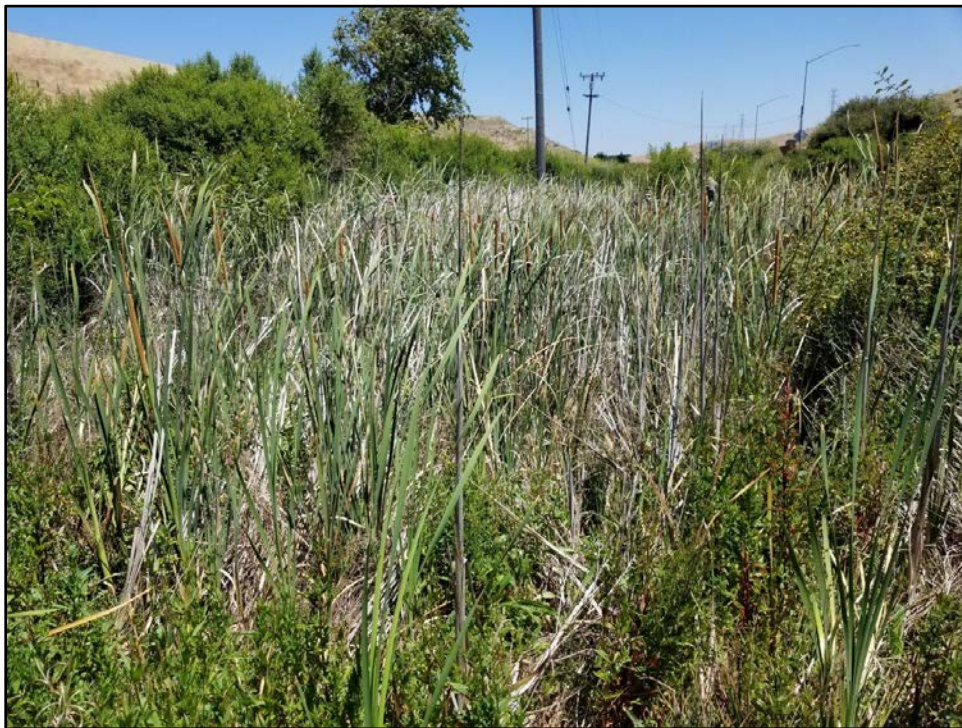
**Photo 8. Sample point SP8 taken to investigate a low-lying area between the westbound I-80 offramp and a frontage road. SP8 was determined to be a three parameter perennial emergent wetland (PEW12). Photo direction = northeast.**

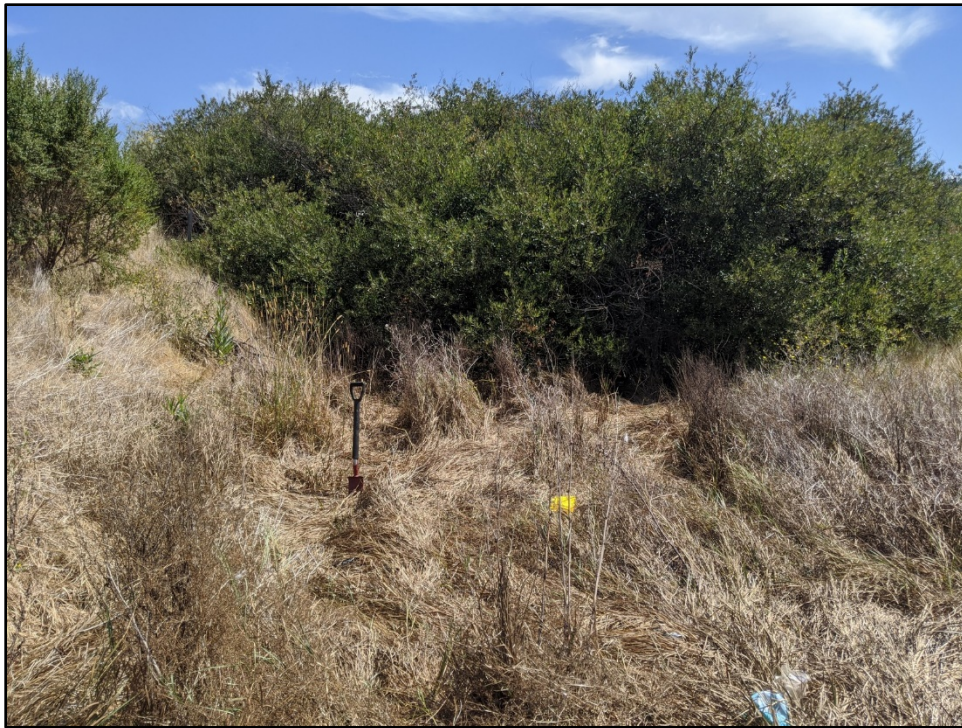
Photo 9. Sample point SP9 taken to investigate a low-lying area between westbound I-80 and a frontage road. SP9 was determined to be a three parameter seasonal wetland (SW8). Photo direction = northeast.

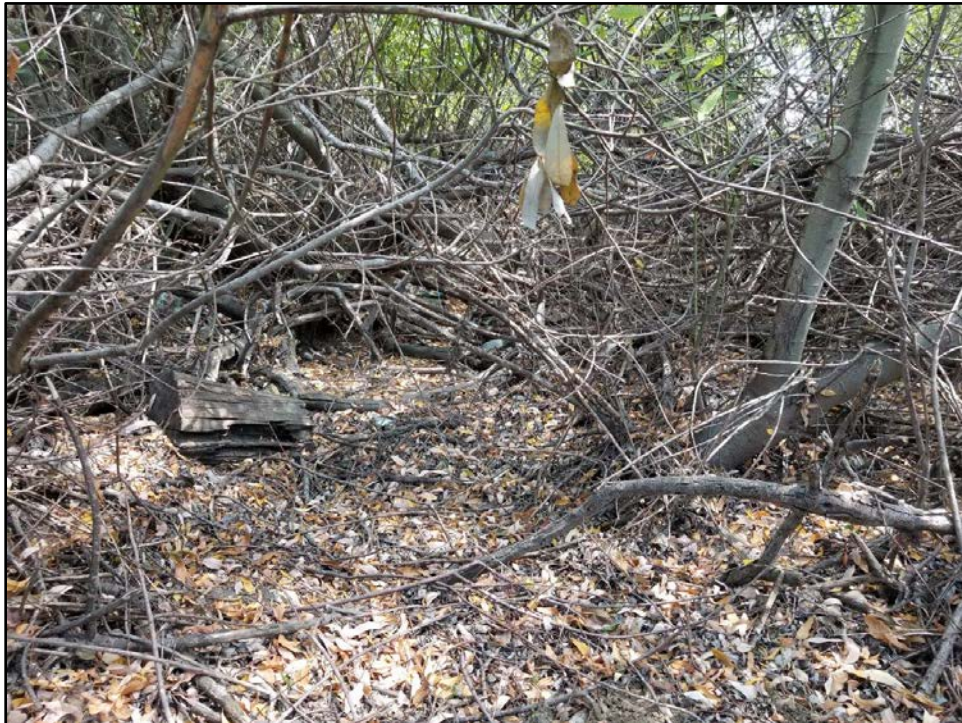
Photo 10. Sample point SP10 taken to investigate a low-lying area between westbound I-80 and a frontage road. SP10 was determined to be a three parameter forested wetland (FW4). Photo direction = northeast.

- SP10 was chosen to investigate a concave surface in the same low-lying area as SP1, SP2, SP3, SP8, SP9, and SP11, but at a lower elevation and in a forested area dominated by arroyo willow (*Salix lasiolepis*), a facultative wetland species. Oxidized rhizospheres were observed along living roots, which is an indicator of wetland hydrology (C3).

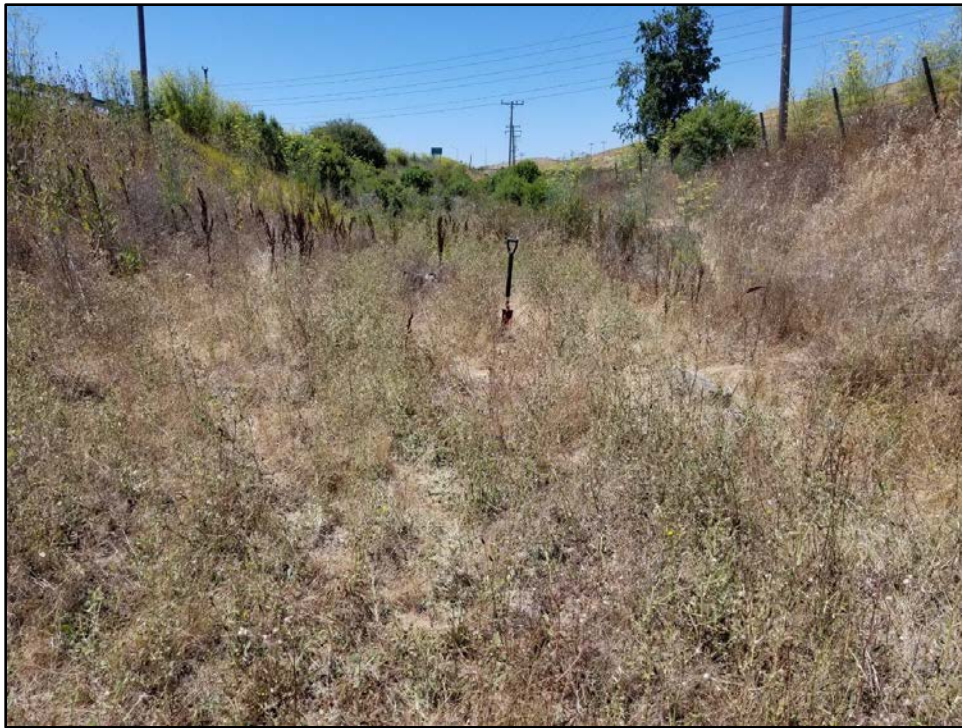
Photo 11. Sample point SP11 taken to investigate a low-lying area between the westbound I-80 offramp and a frontage road. SP11 was determined to be a three parameter seasonal wetland (SW8). Photo direction = southwest.

- SP11 was placed to investigate a concave surface in the same low-lying area as SP1, SP2, SP3, SP8, SP9, and SP10, but at an elevation between SP8 and SP9 and in an area dominated by bristly ox-tongue, a facultative species. Oxidized rhizospheres were observed along living roots, which is an indicator of wetland hydrology (C3).

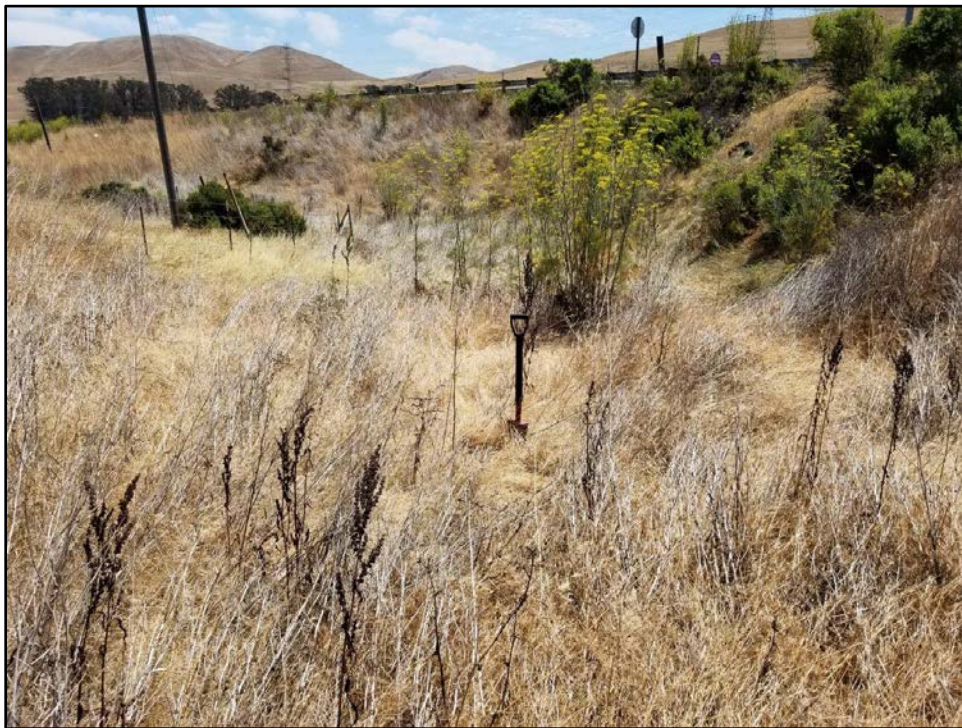
Photo 12. Sample point SP12 taken to investigate a low-lying area between the westbound I-80 offramp and a frontage road. SP12 was determined to not be a three parameter wetland. Photo direction = southeast.

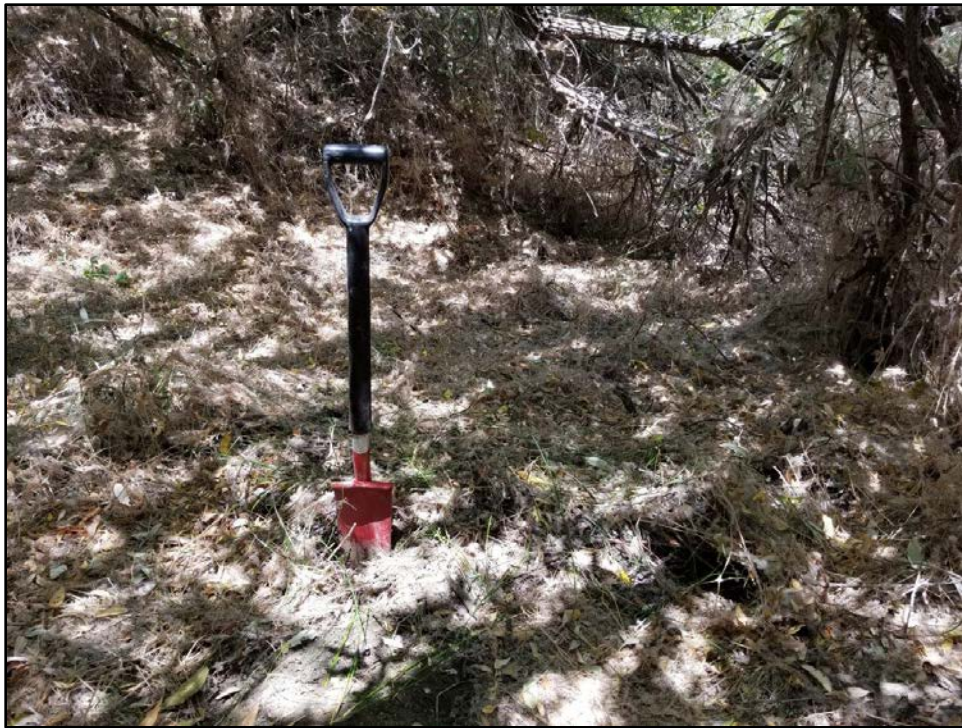
Photo 13. Sample point SP13 taken to investigate a low-lying area between westbound I-80 and offramp. SP13 was determined to be a three parameter wetland. Photo direction = northeast.

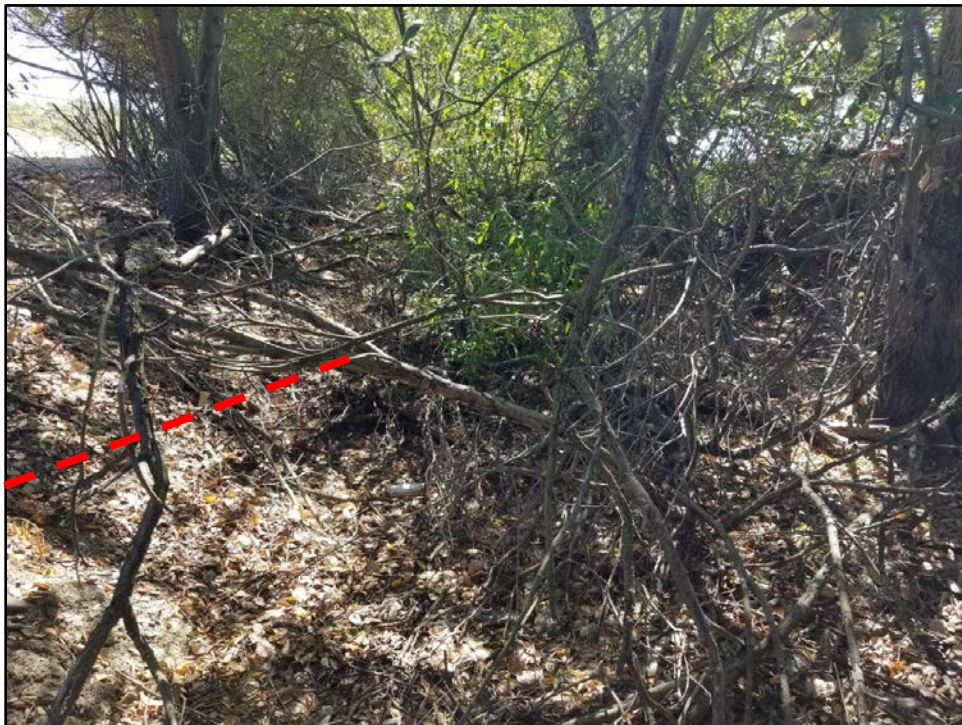
Photo 14. Ordinary high water mark cross-section OHWM-1 taken to investigate an ephemeral drainage (ED2) along the south side of McGary Road east of Hiddenbrooke Parkway. Indicator = break in bank slope (red dashed line). Photo direction = southwest.

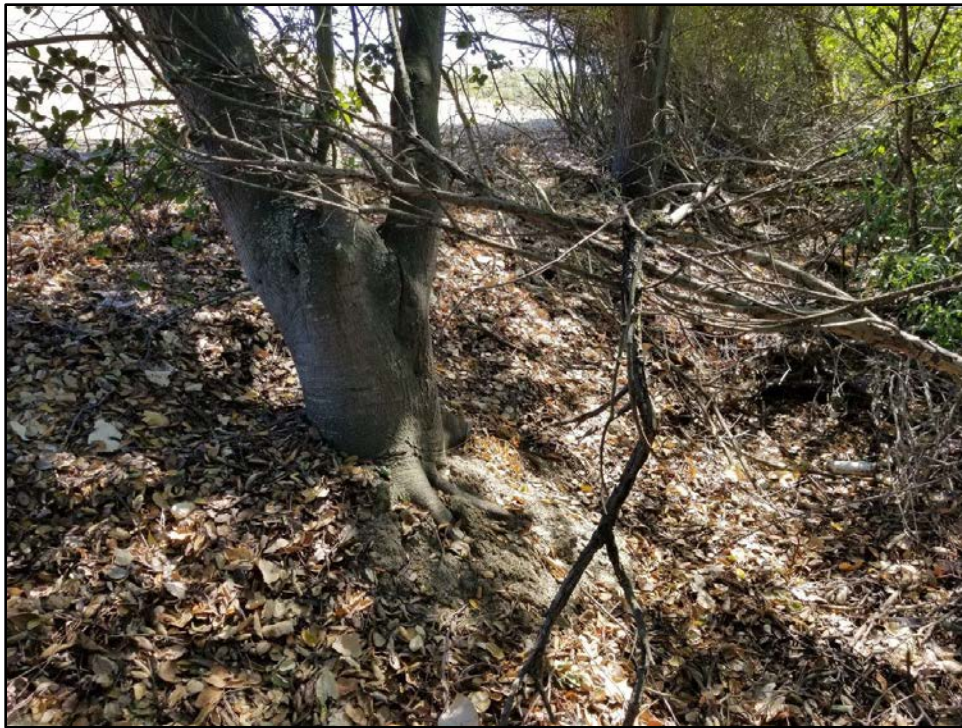
Photo 15. Ordinary high water mark cross-section OHWM-1 taken to investigate an ephemeral drainage (ED2) along the south side of McGary Road east of Hiddenbrooke Parkway. Indicator = exposed tree roots. Photo direction = northwest.

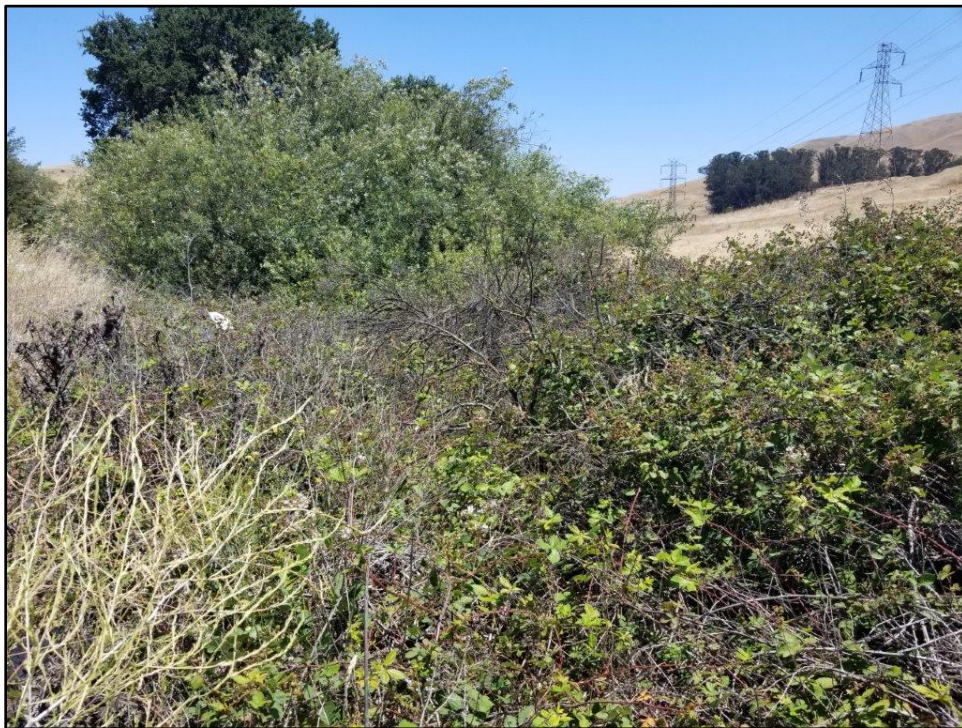
Photo 16. Riparian scrub (foreground) and mixed riparian woodland (background) along an ephemeral drainage (ED2) south of McGary Road east of Hiddenbrooke Parkway. Photo direction = northwest.

Ditches throughout the study area were dug in uplands, drain uplands, and do not appear to be re-constructions of historic drainages (Appendix D, Photos 16 and 17). Therefore, they were considered to be non-jurisdictional.

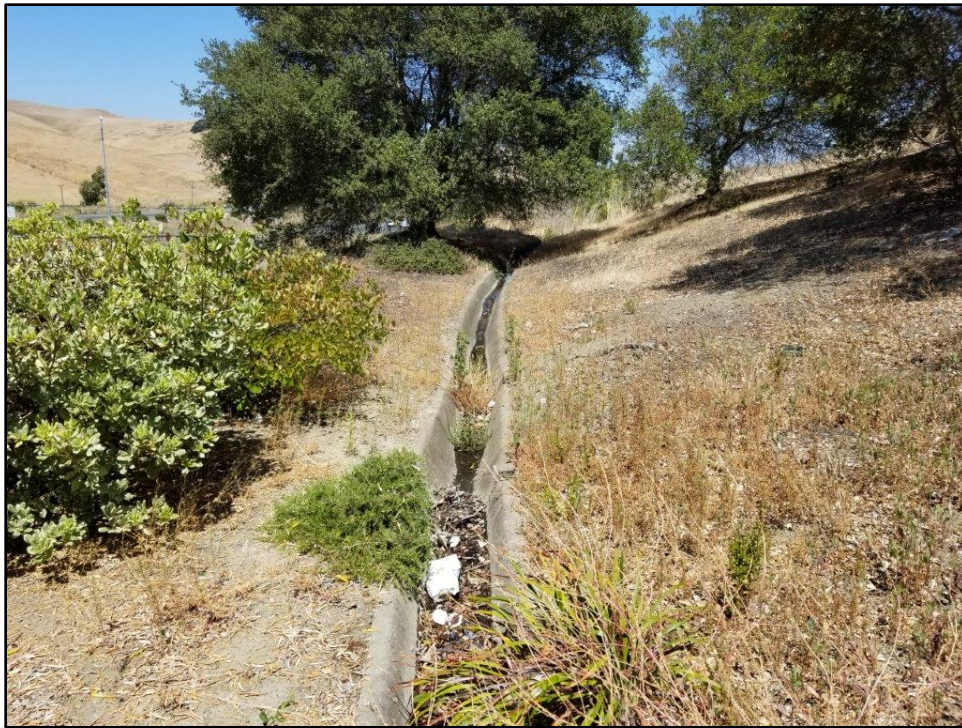
**Photo 17. Concrete ditch south of McGary Road east of Hiddenbrooke Parkway. Photo direction = northwest.**

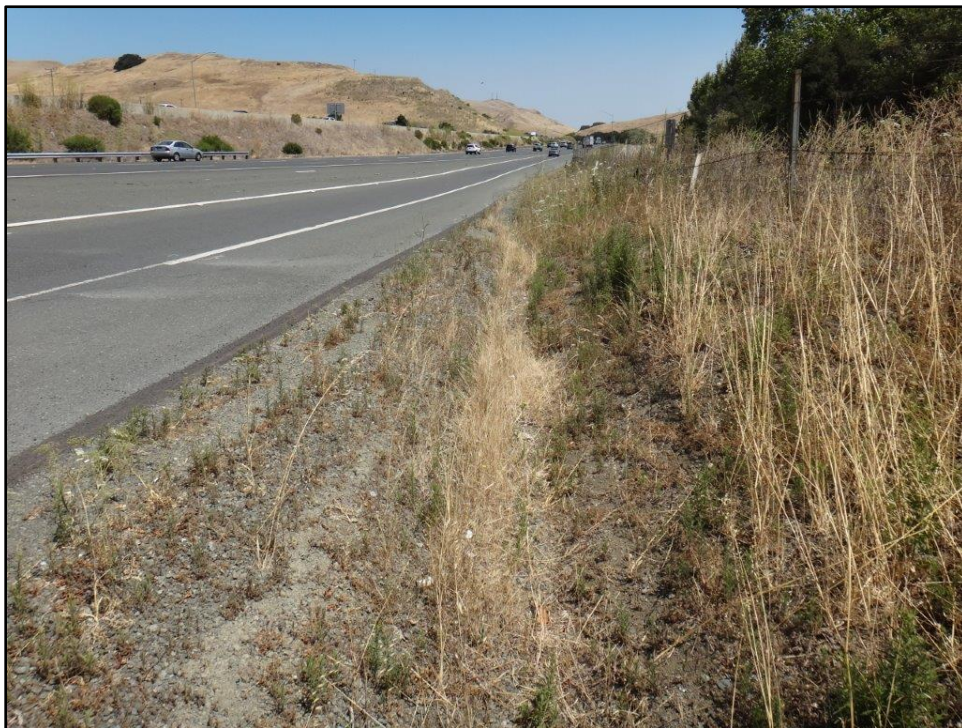
**Photo 18. Earthen ditch south of McGary Road east of Hiddenbrooke Parkway. Photo direction = northwest.**
