**General Biological Assessment
And MSHCP Consistency Analysis
For Tentative Tract No. 37731
A Subdivision of 35.8 (Gross) Acres (32.54 Net Acres) into 138
Single Family Residential Lots, 1 Park and Flood Detention Lots
Located in the City of Riverside, CA**

Assessor Parcel Numbers: 266-140-021, 266-140-022, 266-140-029,
266-140-030, 266-140-049, 266-140-050

TERACOR Resource Management, Inc.
27393 Ynez Road, Suite 253
Temecula, California 92591
office: (951) 694-8000
fax: (951) 694-8035
contact: Samuel Reed, Principal

10 December 2019
Revised per City Comments 24 July 2020
Revised per Wildlife Agency Comments 13 January 2021

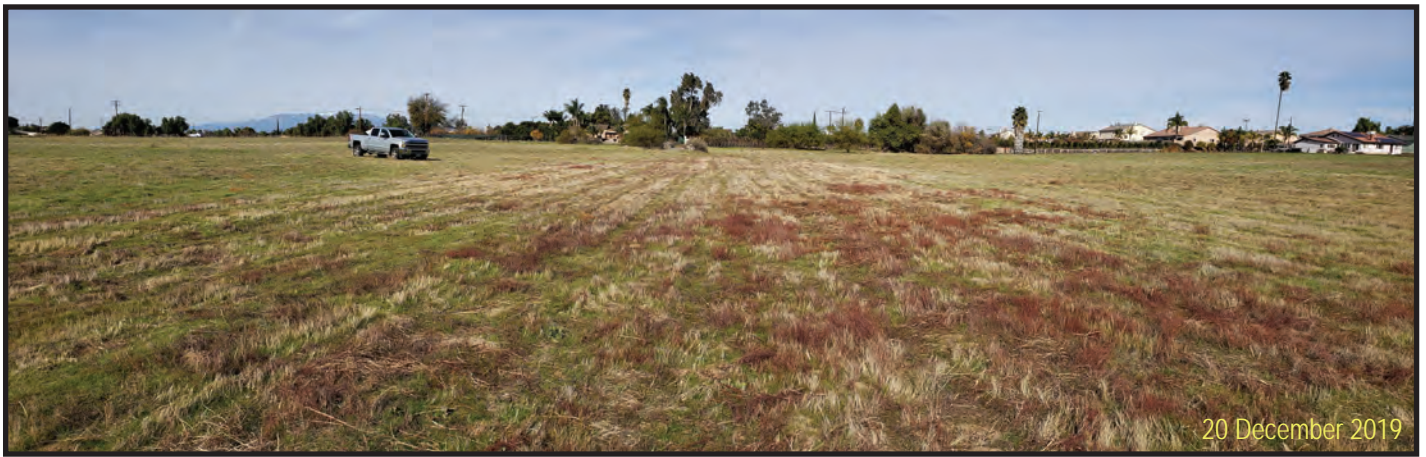
Photo 1 - Northwest end of Tentative Tract Map No 37731. This north-facing photo portrays a non-native grassland which seasonally conveys sheetflows. Common knotweed (*Polygonum sp.*) is the reddish-brown plant, a common yard weed.

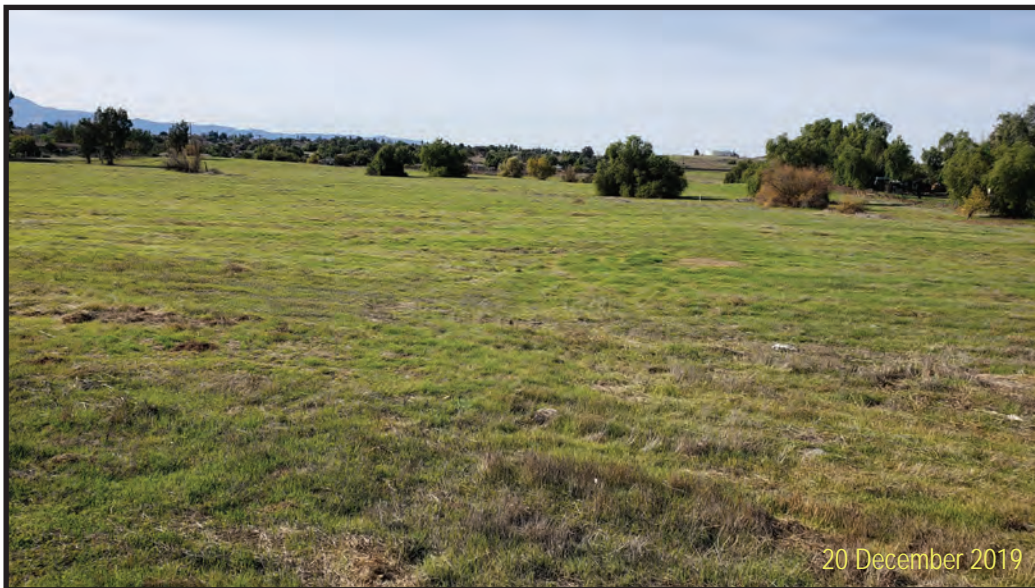
Photo 2 - South end of Tentative Tract Map No. 37731. Photo faces west. The annual non-native grassland contains pepper trees in this area.

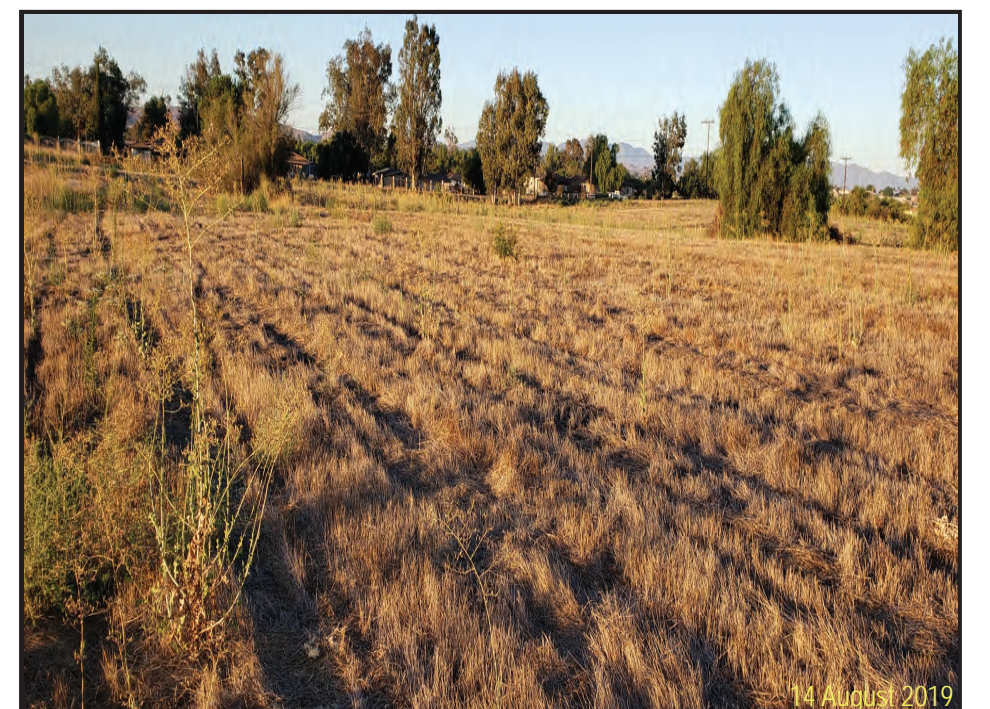
Photo 6 - In the southeast section of property facing Mariposa Avenue. A number of CA pepper trees are present, in addition to willows and salt cedar in drainage areas.

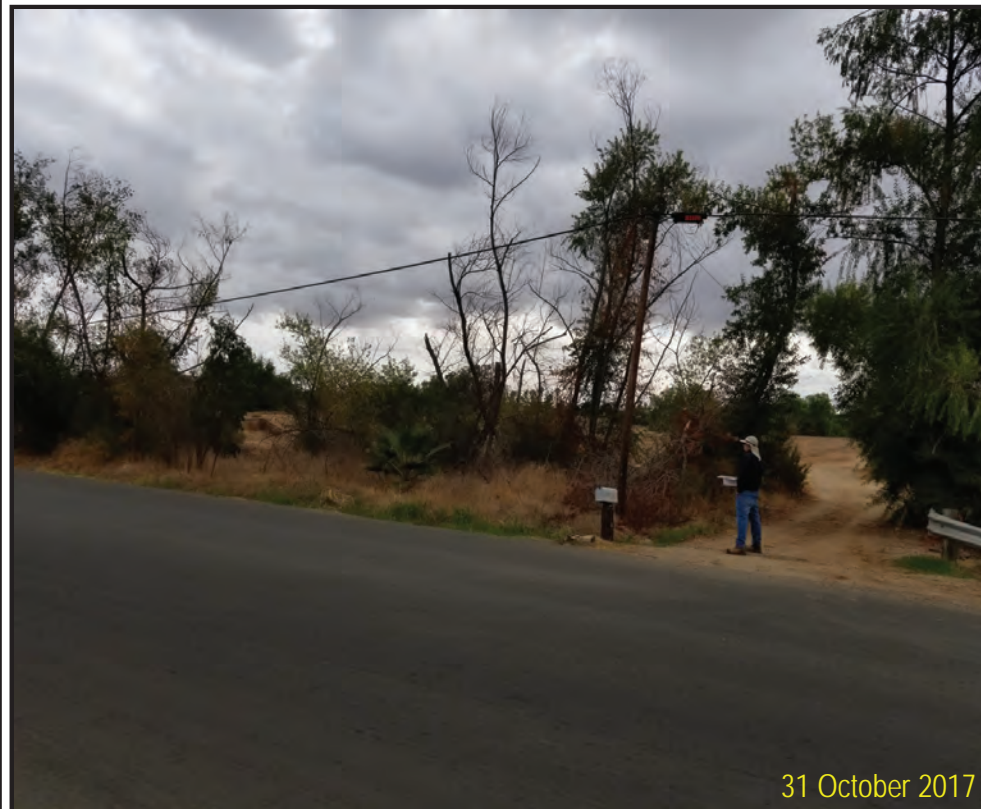
Photo 1 - TERACOR personnel shown at the downstream end of Feature 1 at the northwest corner of the project site. Note the stressed condition of the willows due to re-trenching the earthen channel along Lurin Avenue, and subsequent water-deprivation.

TERACOR preliminarily determined that **Feature 1** was an artificial roadside drainage and is not Riparian/Riverine by definition. The Wildlife Agencies found otherwise in their review of historic aerial analysis. Due to persistent urban runoff from development to the north, Feature 1 supports riparian vegetation. Feature 1 exhibited six (6) of the eight (8) MSHCP-listed functions and values described in Section 6.1.2. Despite its artificial origins and declining riparian shrub cover (resulting from retrenching the Lurin Avenue ditch) the Wildlife Agencies have concluded Feature 1 (**0.03 acre**) is Riparian/Riverine.

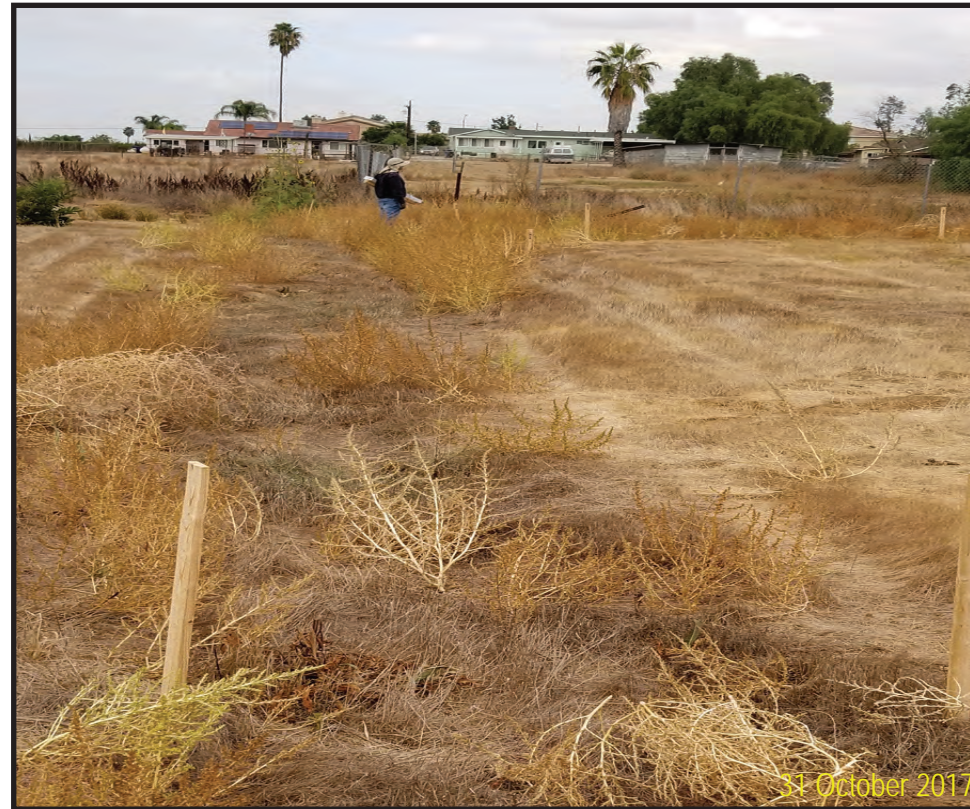
Photo 2 - Upstream view of Feature 2 facing property line where stormwater enters the site and flows along the western property line. No discernible water marks, or other stream features are apparent.

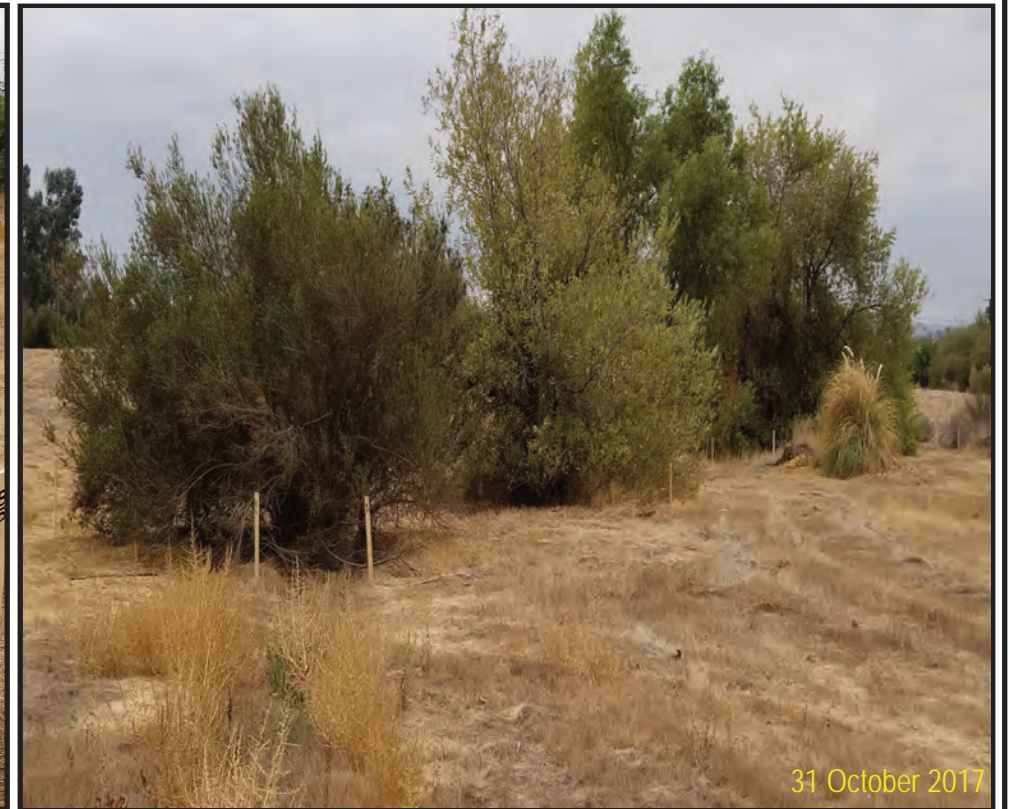
Photo 3 - Downstream view of the arroyo willow / mulefat scrub associated with Feature 2.

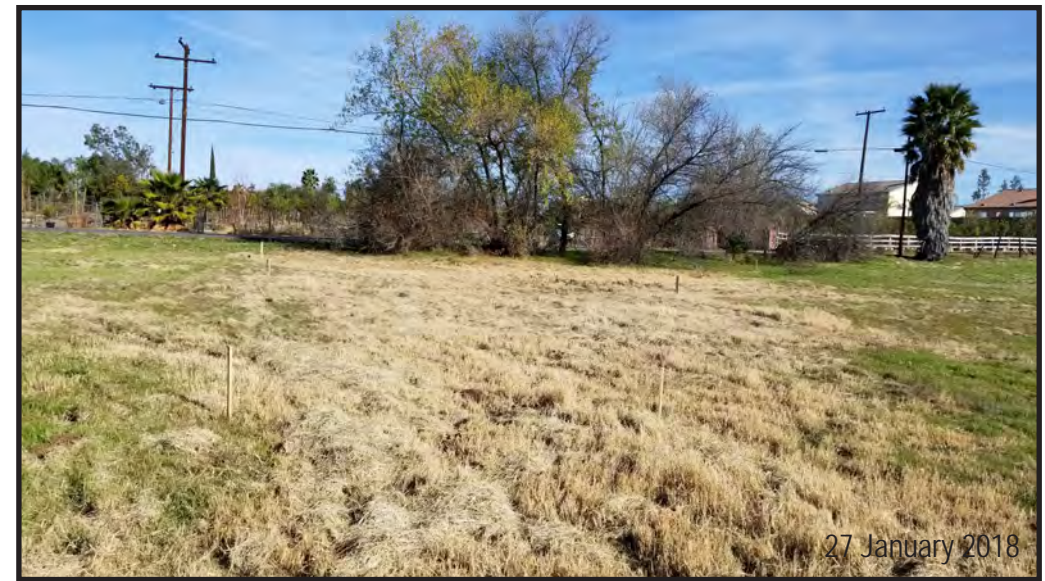
Photo 2 - Vegetation within Feature 5 transitions from a willow/mulefat scrub cell to non-native grassland in its upstream portion near Lurin Avenue. The brown vegetation is Bermuda grass, and a plant listed as an invasive by the MSHCP.

Feature 5 exhibits six (6) of the eight (8) MSHCP-listed functions and values. It originates on the south side of Lurin Avenue, at the discharge point of a 12-inch corrugated metal pipe (CMP) under Lurin Avenue. The drain is heavily damaged and drainage was nearly blocked. Overflow drainage appears to originate across Lurin Avenue in a plant nursery, crosses Lurin Avenue, then enters the Project site where sandy loam soils appear to absorb most runoff. The small willow cell has developed at this location, surrounded by volunteer Palo Verde trees, one Mexican fan palm, and agave-type cactus. Feature 5 is **0.03 acre** in extent.

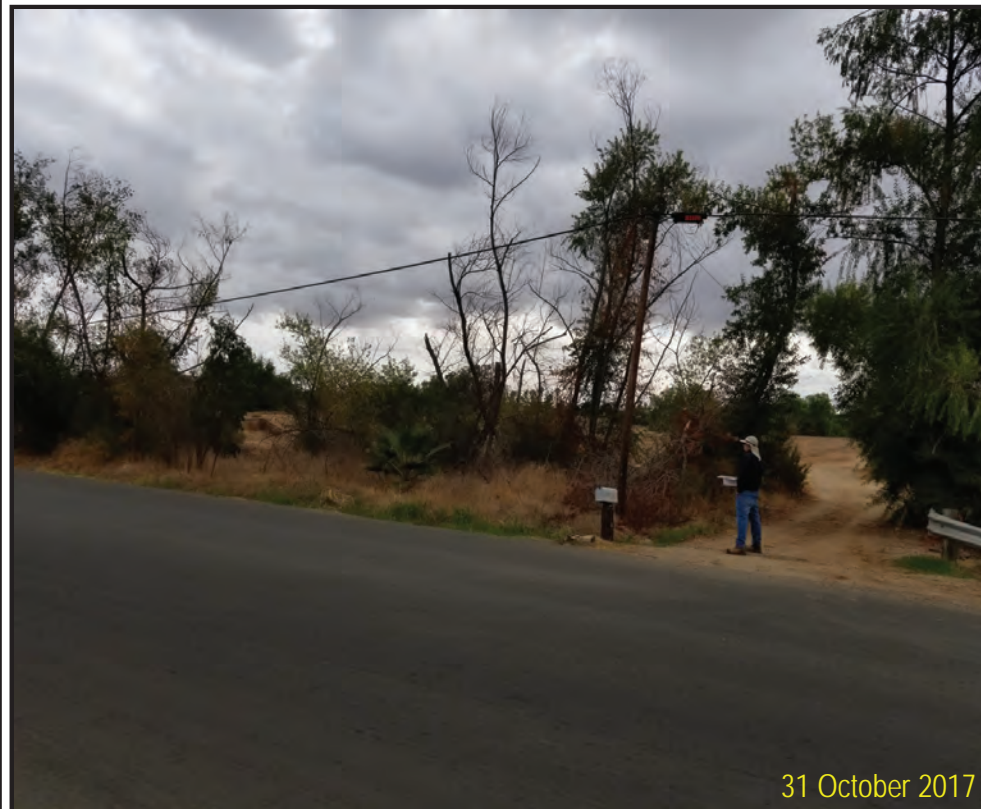
Photo 1 - TERACOR personnel shown at the downstream end of Feature 1 at the northwest corner of the project site. Note the stressed condition of the willows due to re-trenching the earthen channel along Lurin Avenue.

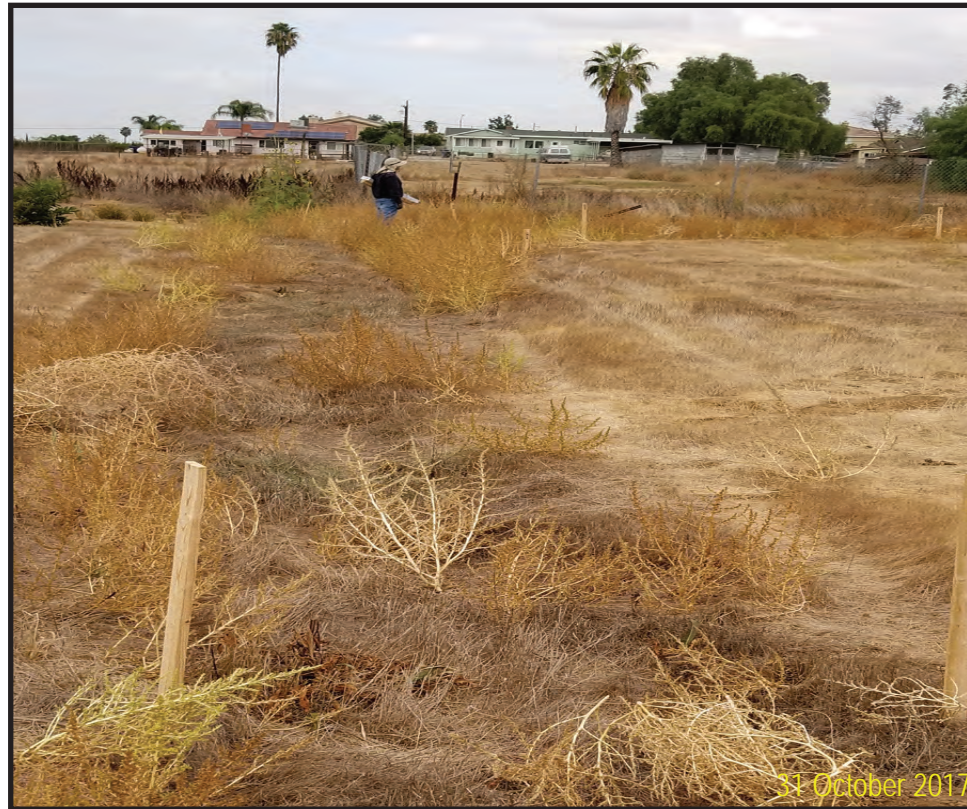
Photo 2 - Upstream view of Feature 2 facing property line where stormwater enters the site and flows along the western property line. No discernible high water mark or bed and bank is present.

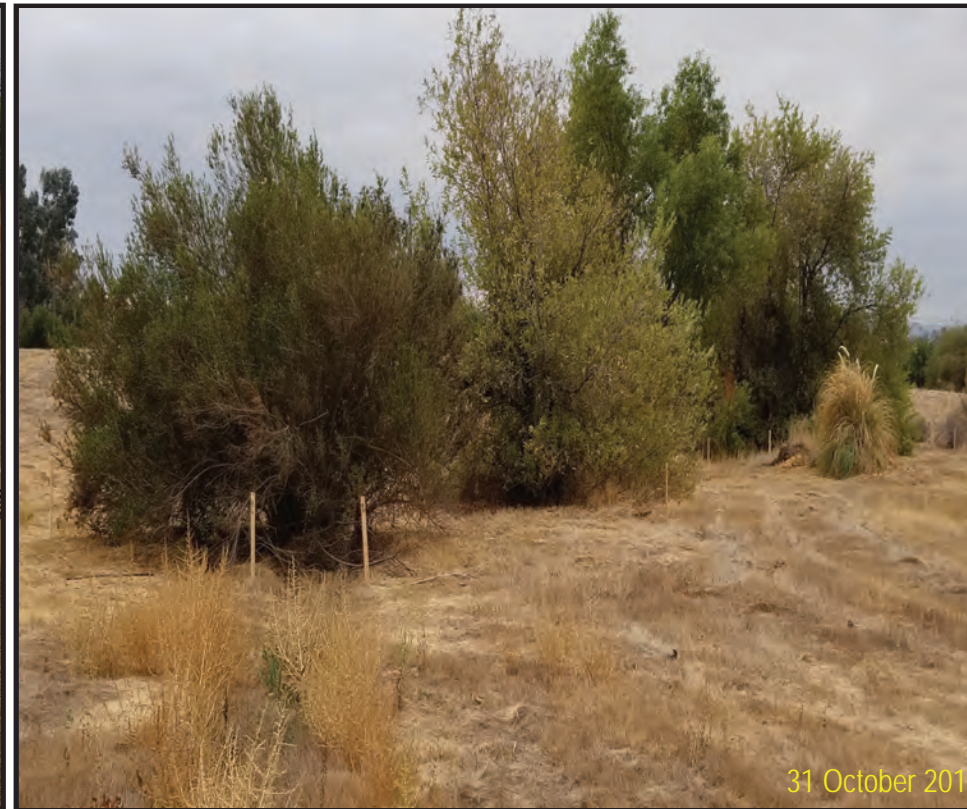
Photo 3 - Downstream view of the arroyo willow / mulefat scrub associated with Feature 2.

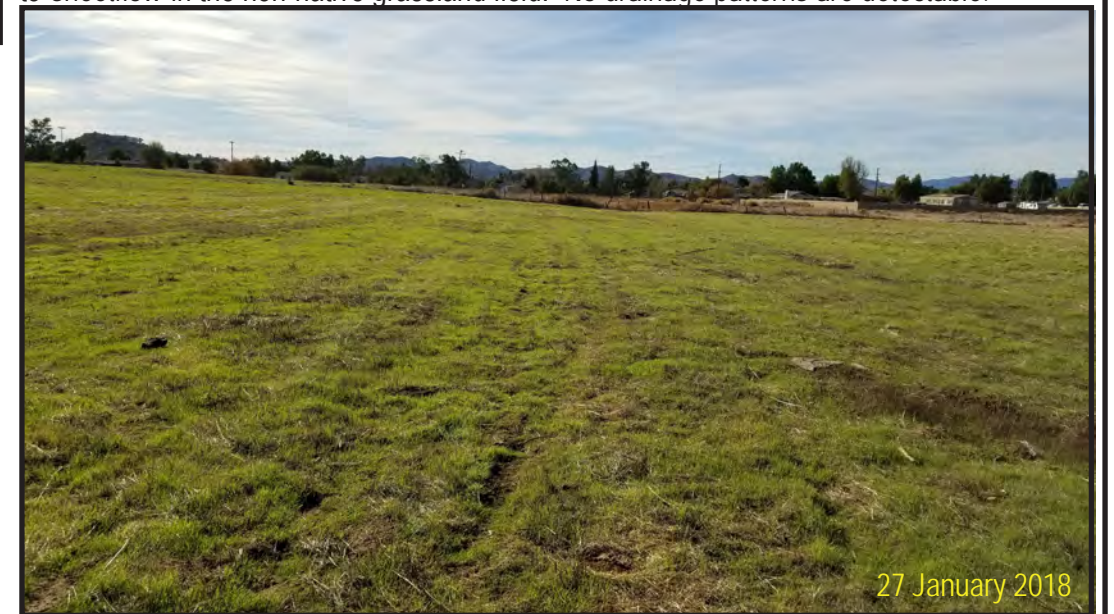
Photo 5 - This southern view shows that Feature 5 illustrates how stormwater transitions to sheetflow in the non-native grassland field. No drainage patterns are detectable.
